Badley Church Green

CONSERVATION AREA APPRAISAL

Text, photographs and map overlays by Patrick Taylor, Conservation Architect, Mid Suffolk District Council 2012.

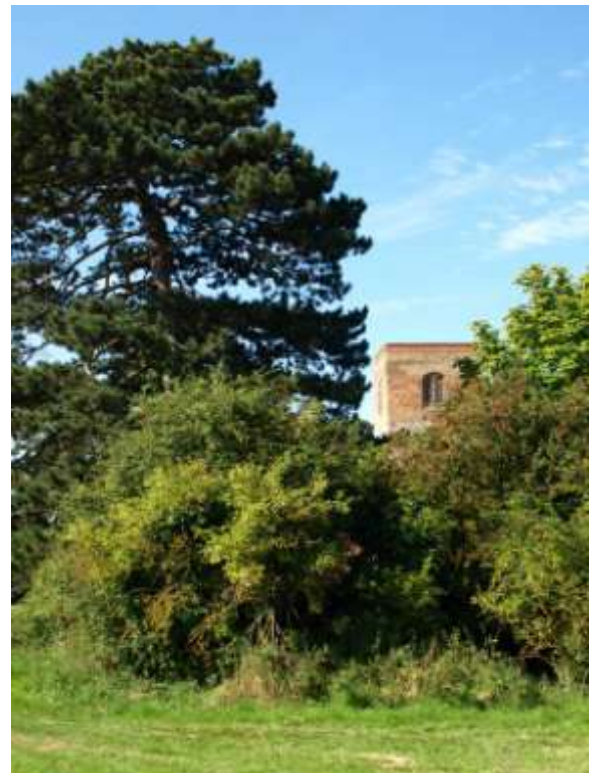
Badley Church

The medieval Church of St Mary is listed grade I and dates mainly from the 15th Century. Built of flint rubble, now rendered in places, it has limestone dressings and a plaintile roof. It has a brick stage to the top of the tower and the south porch is interestingly timber-framed, originally 14th Century but largely rebuilt in the 20th Century. It suffered badly in the hands of William Dowsing and his 'puritanical vandals' in the 17th Century, when 34 'superstitious pictures' were destroyed. Fortunately the 19th Century restoration did not much affect the exterior and to this day it retains its box pews and pulpit inside.

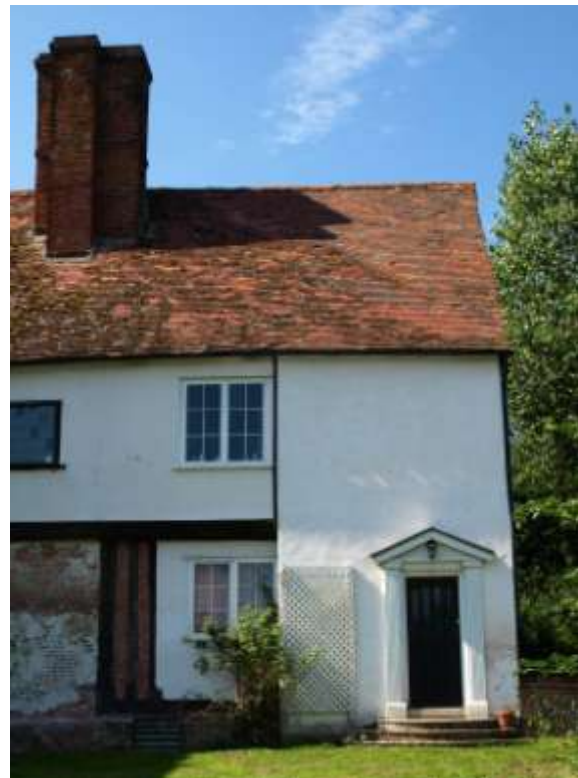
Badley Hall

The Hall was originally much larger, built to a traditional quadrangular plan, until 1759 when the northernmost two thirds were demolished following storm damage.

The older domestic buildings around the parish are generally of timber-framed construction with applied lime render finish, occasionally with exposed timbers. The dovecote is similarly constructed with a plaintile roof, but the exposed timbers here are due to failed render. The Hall is also timber-framed and plaintiled, but of higher status with a decoratively carved bressumer along the east front above some brickwork with painted on brick patterning.

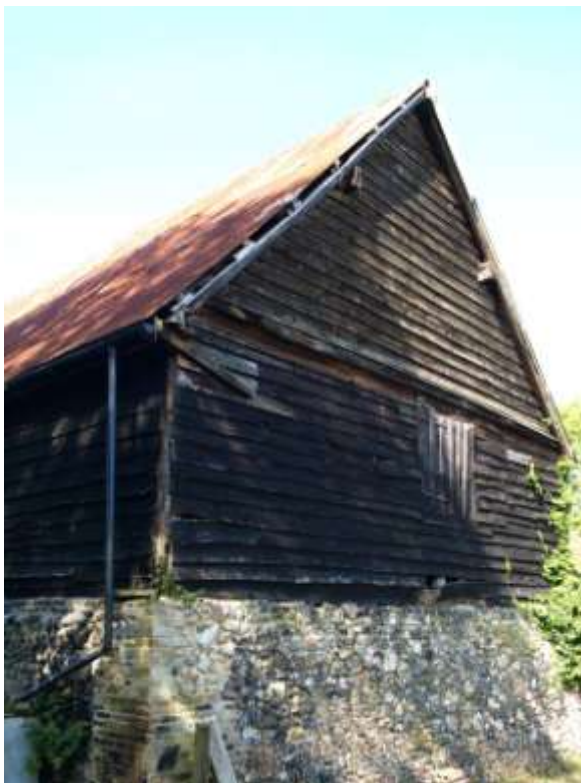
Chantry Barn

In contrast the Church is of flint and septaria with limestone dressings and brick to the top of the tower. The barn has a high flint built plinth with red brick dressings topped by black feather-edged weather-boarding on a timber-framed construction. Unfortunately the barn's thatched roof has been lost and replaced with corrugated iron and asbestos.

Now that it has been repaired, Badley Hall itself has been taken off the Suffolk County Council register of Buildings at Risk. However its barn, bakehouse and dovecote remain on the register in view of their continuing poor condition. Recent frame and render repairs to the dovecote are a step in the right direction, but the others still remain in need of works. The corrugated iron and asbestos roof to the barn is intrusive, but at least keeps the weather out.

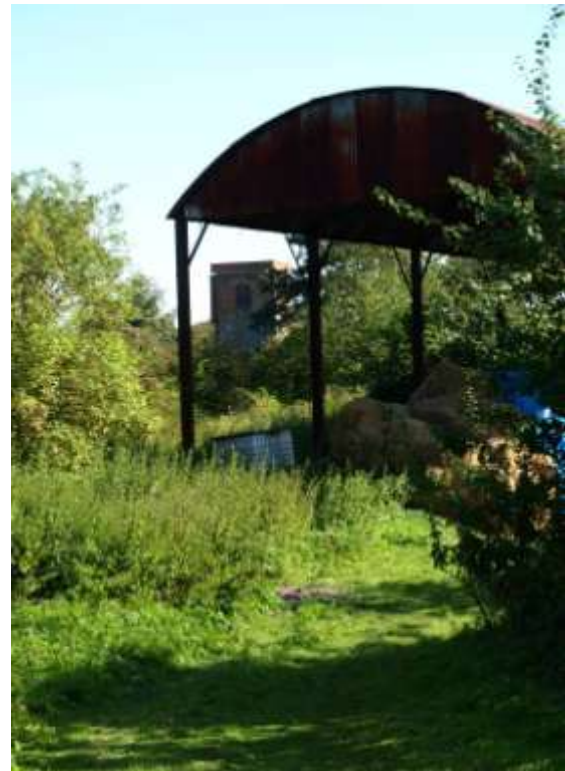
Modern Barn

Less visually pleasing are some of the modern additions around the former farmyard and indeed the three lines of pylons that march across the landscape without respect to the linear axis focusing on the Hall.

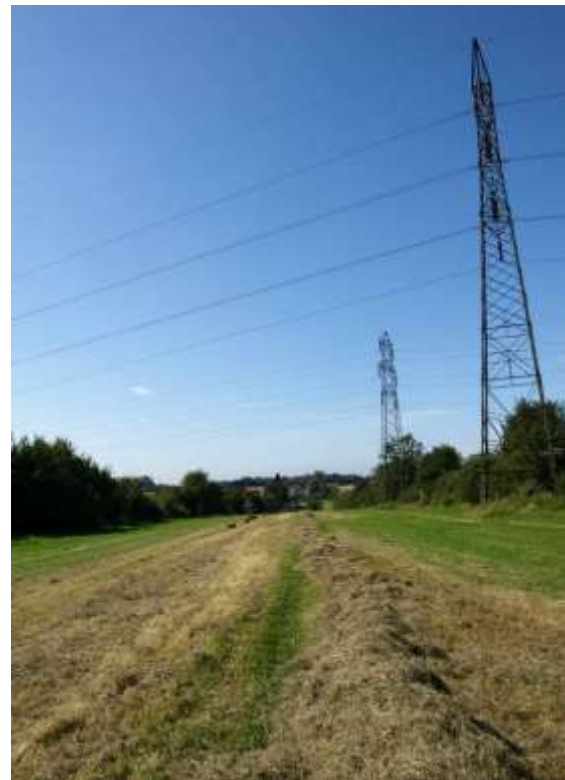
Pylons over Badley Walk

Unfortunately one feature, which continually contradicts the village's apparent isolation, but does provide a useful reference point for walkers, is the group of overhead power lines which converge to a point north of Church Green. Three of these actually cross the avenue, east of the Church.

The whole area could be improved by the implementation of an ongoing management plan for the trees to emphasise this axis. The access road along Badley Lane could also be repaired and improved in a suitable low key way to maintain a rural feel.
