Babergh District Council  
Bentley Conservation Area Appraisal and Management Plan  
November 2025

# Bentley Conservation Area Appraisal and Management Plan\*

25 November 2025

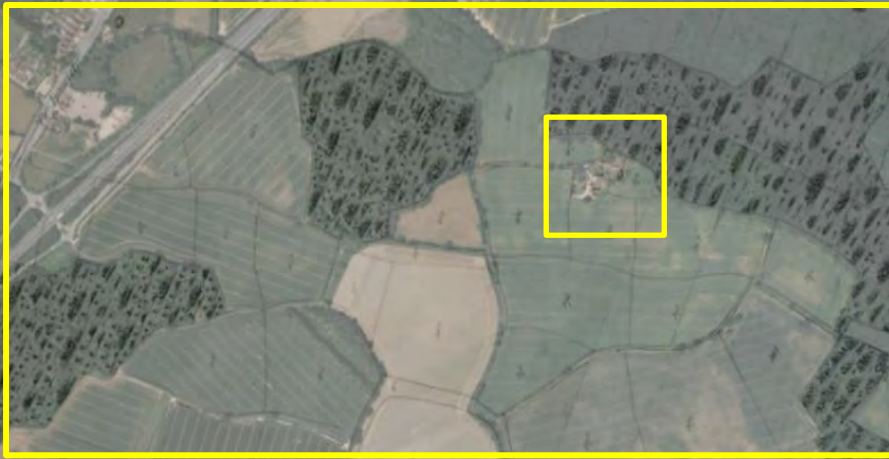
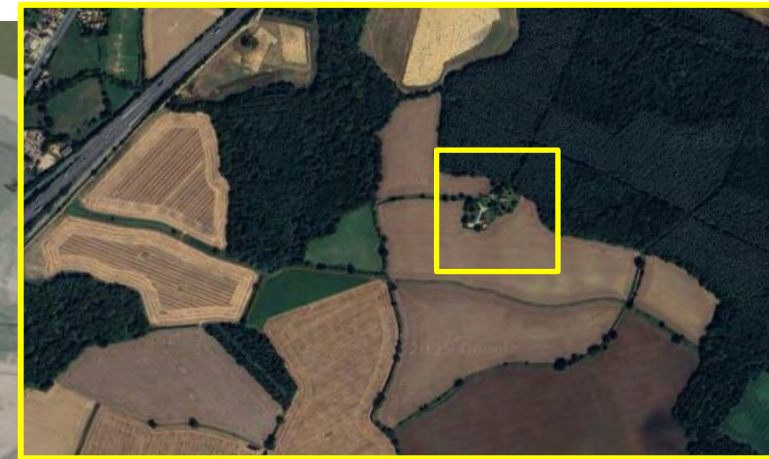
figures 19:  
**Examples of surviving small fields in and around Old Hall from the time of the 1838 Tithe Map as found in the landscape today.**

[note the resemblance between the current pattern and that described earlier from 1613.

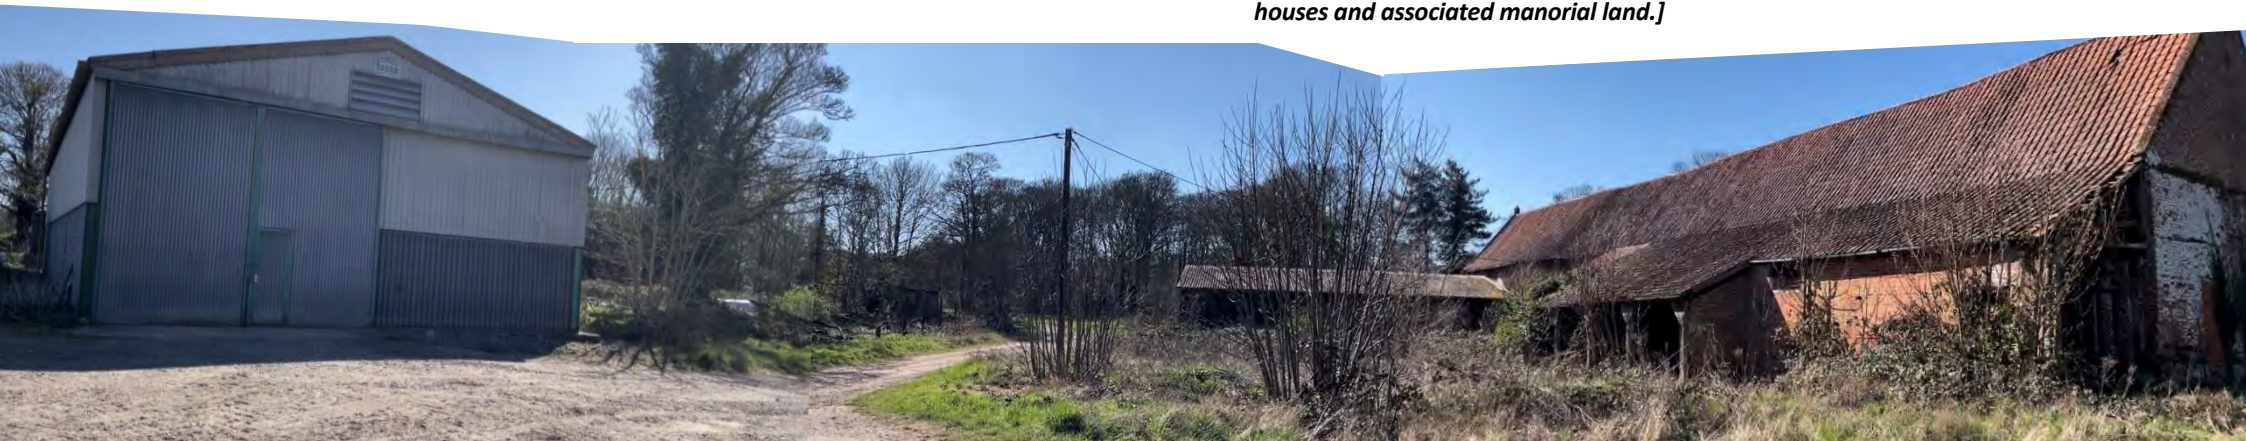
figure 92: An unfortunate juxtaposition. Modern industrial style agricultural metal shed adjacent to the Grade I listed, 'Elizabethan' Bentley Hall Barn. Whilst both may be said to have an agricultural provenance, the modern interloper harms the setting of the magnificent and historically important 'Elizabethan' barn.

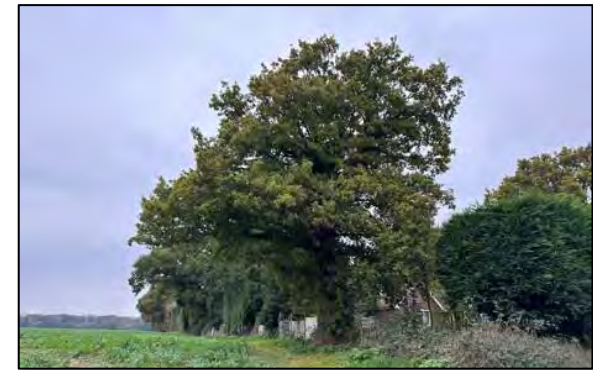
figure 107:  
**Run down and dilapidated fencing along the southern side of Little Bush, south of St Mary's Church would benefit from sensitive repair or replacement.**

Boundary treatments on the whole have a rustic and modest appearance. Where they have not been successful is where modern, tall, close boarded fencing, or industrial metal palisade fencing have been introduced. The former restricts views into the grounds having a negative impact on views, the latter introduces an incongruous industrial feature into the area. Both would benefit from removal for more sensitive open boarded fencing where possible. Similarly, a number of signposts have been erected in the area with a metal mass manufactured appearance and would benefit from replacement with bespoke timber units, which would be more complementary to a rural nature of the area.

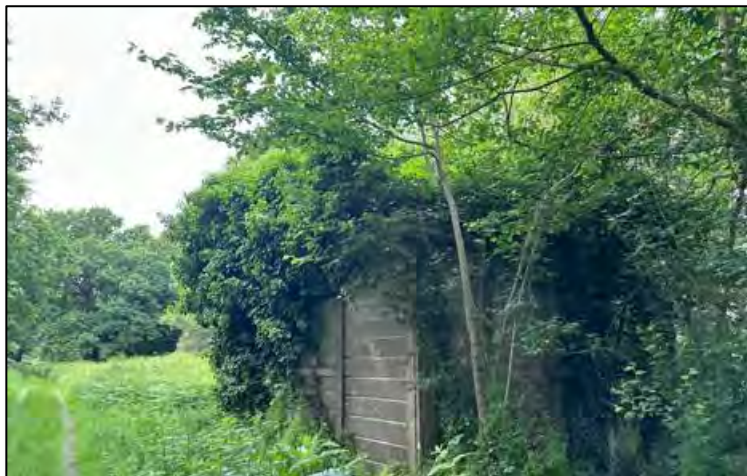
figure 108:  
**Former railway platelayer hut in a poor state of repair.**

There are a few other structures in the area that have been neglected including the platelayer hut along the former Bentley-Hadleigh branch line and outbuilding close to Pond Hall. With regards to the former, this would benefit from repair and potentially information boards which would better reveal its significance. With the latter this would benefit from either demolition or repair/replacement.

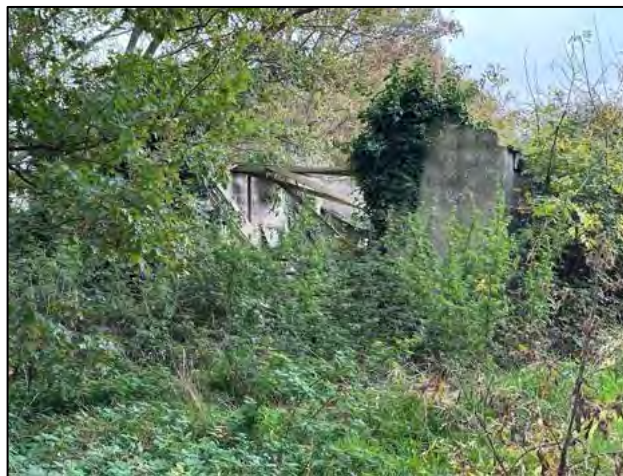
figure 109:  
**There are a number of scattered dilapidated buildings across the conservation area that would benefit from repair restoration or removal (here to the south-west of Pond Hall).**

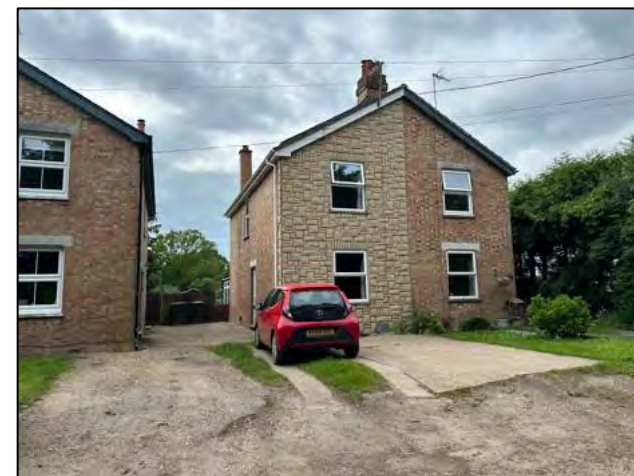
figure 110:  
**Inappropriate stone cladding to Falstaff Cottages [pre-dates conservation area]**

In relation to point 3, there are a surprisingly limited number of buildings that have been insensitively adapted, with many featuring their original details or appropriate modern interventions. Some properties along Potash Lane have had their original fenestration details altered and replaced with unsympathetic uPVC units. The reintroduction of appropriate timber windows and original fenestration would have a beneficial impact on the building and in turn the wider conservation area. Similarly, one of the Falstaff cottages has had its facade replaced with stone external wall cladding. Stone is not found in modest domestic buildings in the conservation area, and it has unbalanced the symmetry of the original building. Its removal, subject to the condition of the bricks beneath, would provide a beneficial impact to both the building and the conservation area. Historic photographs can also be a helpful source of information when deciding on what details are appropriate to reinstate (appendix 4).

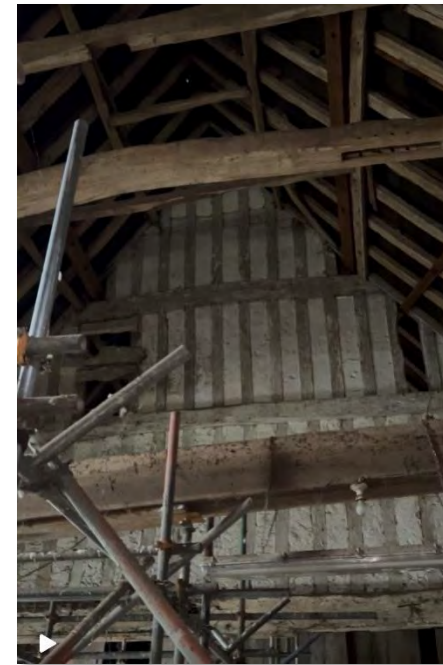
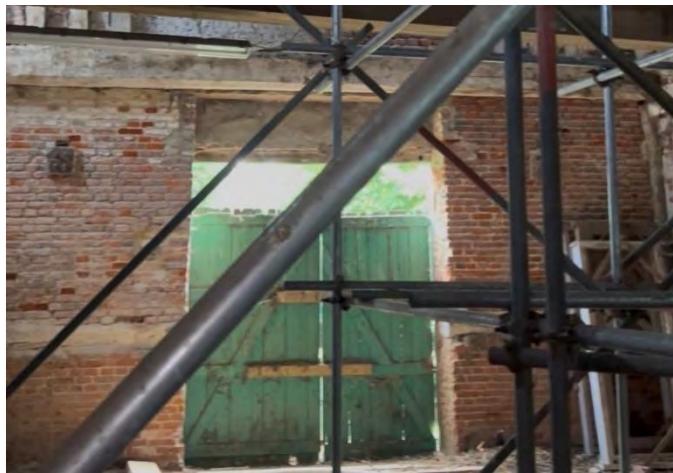
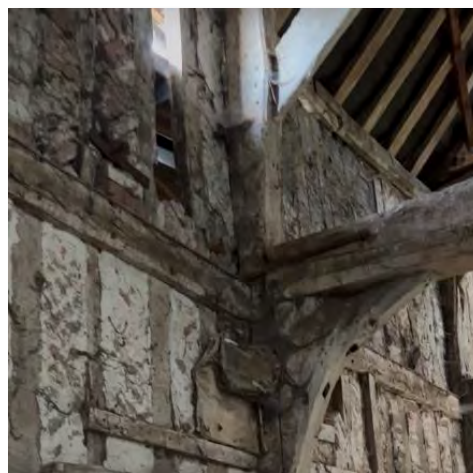
figures 126: **Bentley Hall Barn Interior [2025]**

**In relation to point 2**, the most noticeable derelict building in the area is the grade I listed Bentley Hall Barn. This building is of the highest significance and is on Historic England's At Risk Register. It is imperative that a sensitive use is adopted for the building to ensure its future survival and optimum viable use. The removal of modern elements attached to the building and some limited development based on former historic structures to the east of the barn (seen on the historic mapping and historic photograph in appendix 4) would provide a helpful framework for future development.

The most noticeable building in need of restoration in the Conservation Area, is Bentley Hall Barn, which is a Grade I listed Elizabethan barn. It is a priority that the building is repaired and restored as it has been empty for a number of years and its condition has deteriorated. The current owner has taken steps to try and keep the building weather and watertight, but the work undertaken is only providing temporary protection and the buildings itself is vulnerable for a number of reasons. The future wellbeing of this important heritage asset needs to be secured, and the Council will encourage the owner to consider appropriate re-use of the building.

The Council therefore intends to maintain direct discussions with the owner of the building with the prospect of identifying a development proposal that will secure the buildings future and allow for its immediate restoration.

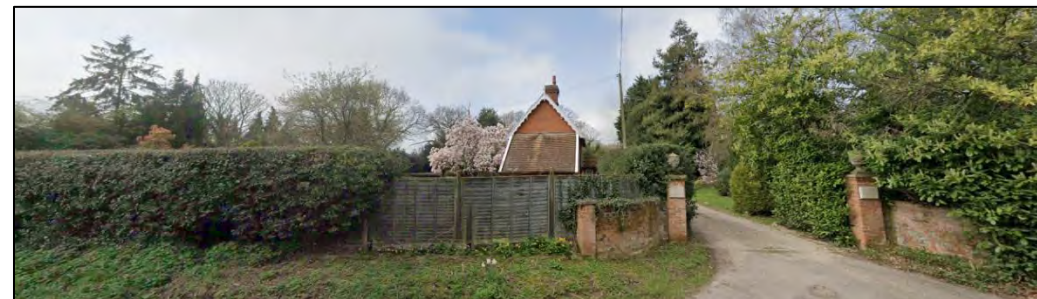
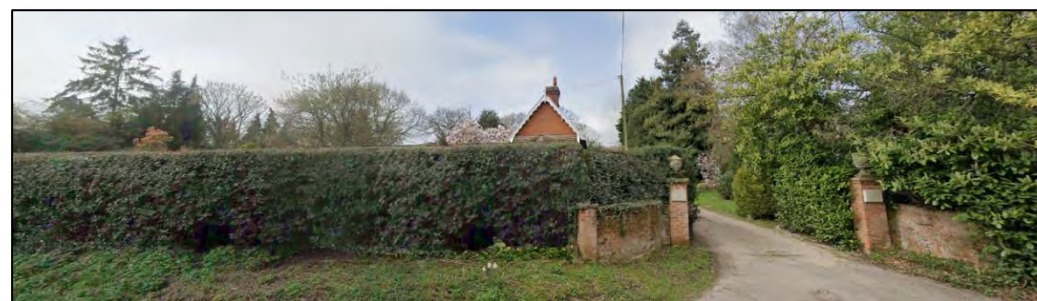
figures 128:  
**Example of how character and appearance might be enhanced [mock-up image] Cottage adjacent to St. Mary's Church**

Boundary treatments on the whole have a rustic and modest appearance. Where they have not been successful is where modern, tall, close boarded fencing, or industrial metal palisade fencing have been introduced. The former restricts views into the grounds having a negative impact on views, the latter introduces an incongruous industrial feature into the area. Both would benefit from removal for more sensitive open boarded fencing where possible. Similarly, a number of signposts have been erected in the area with a metal mass manufactured appearance and would benefit from replacement with bespoke timber units, which would be more complementary to a rural nature of the area.

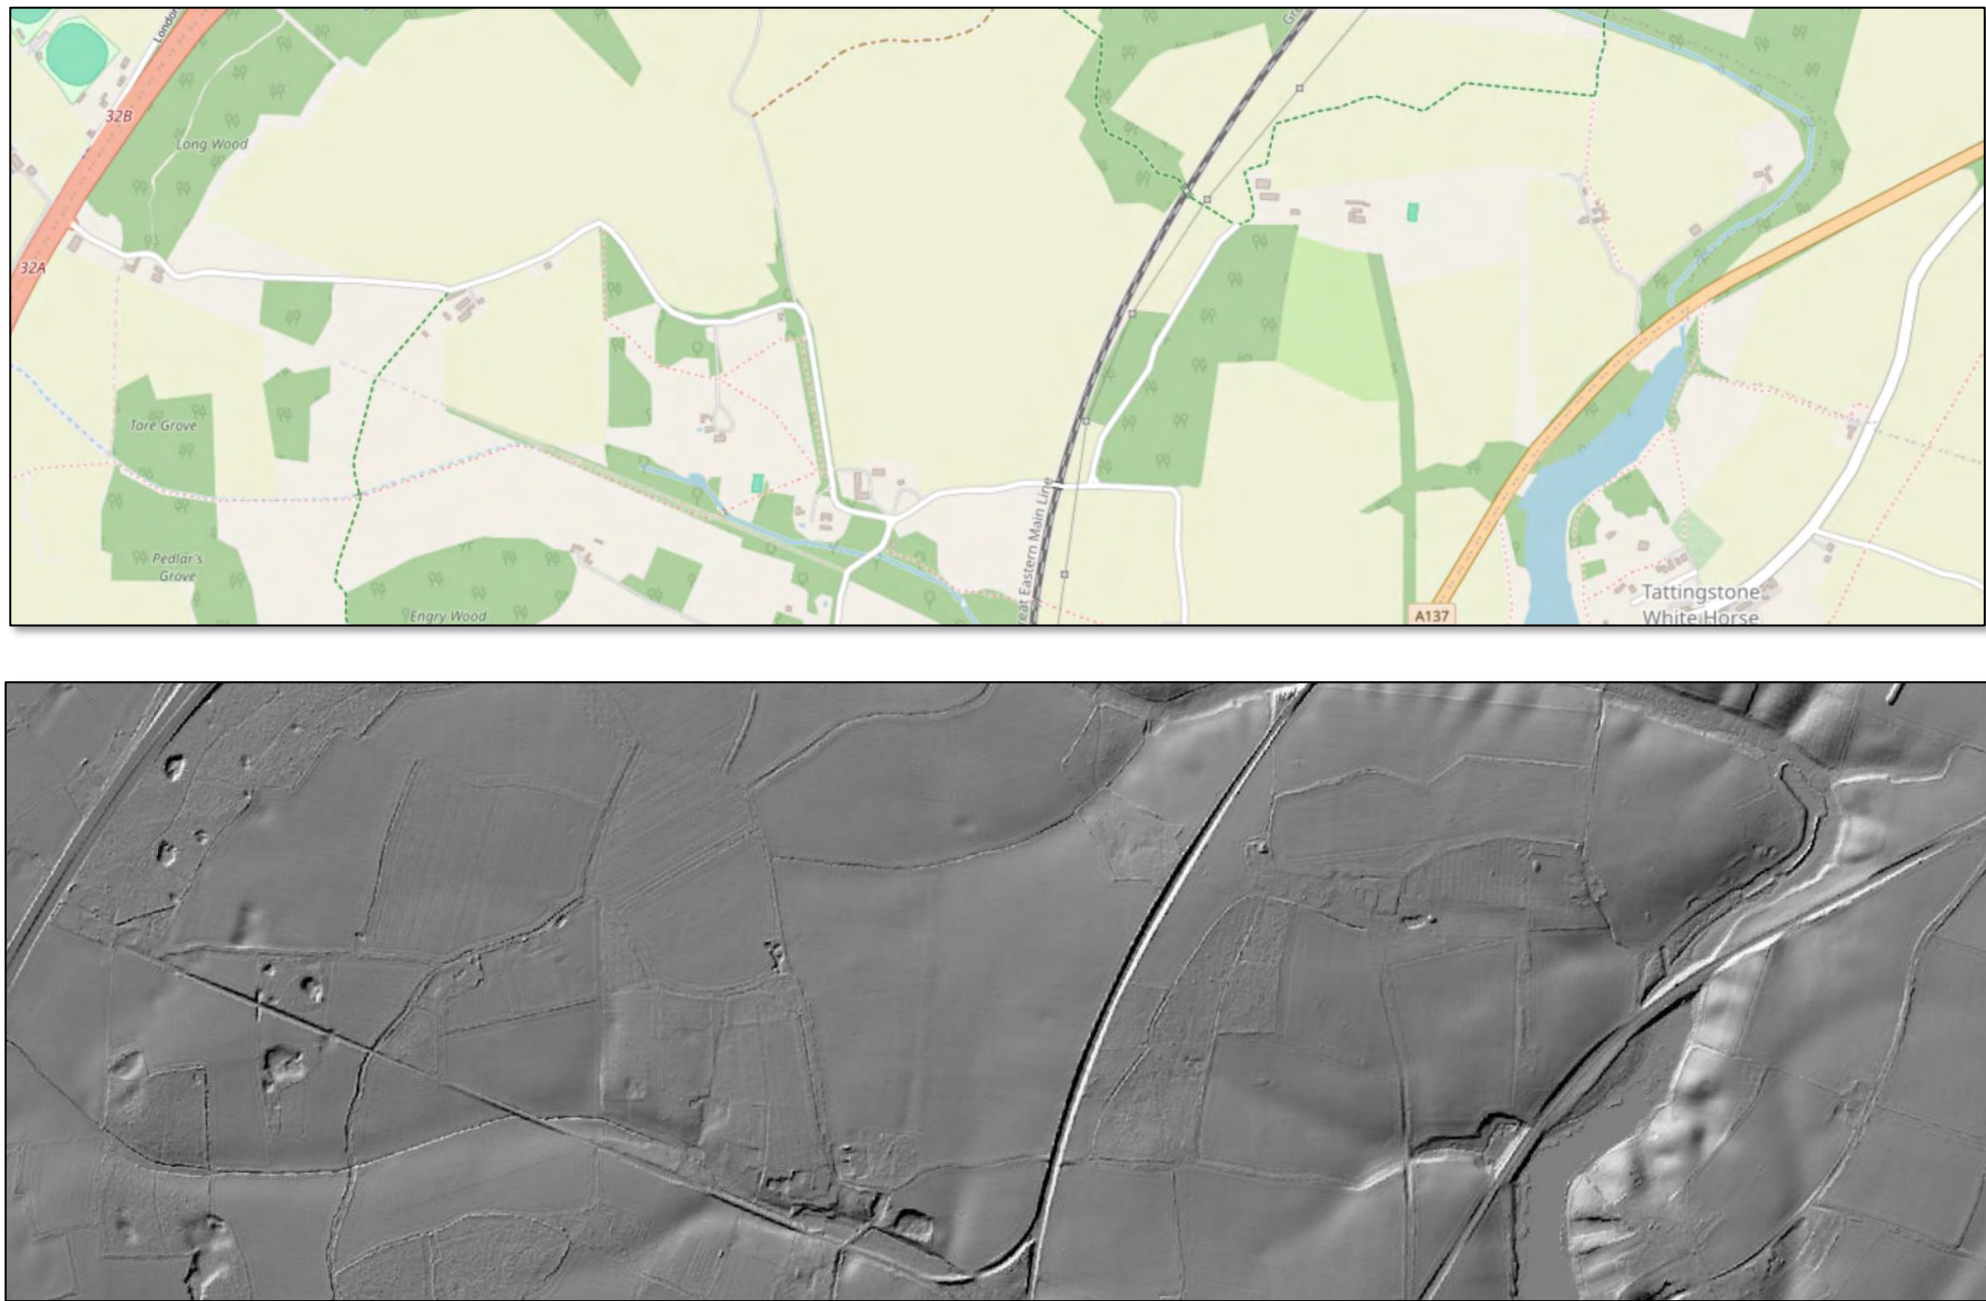
figure 168: Map and comparative LIDAR image: Central and eastern parts of the Bentley Conservation Area

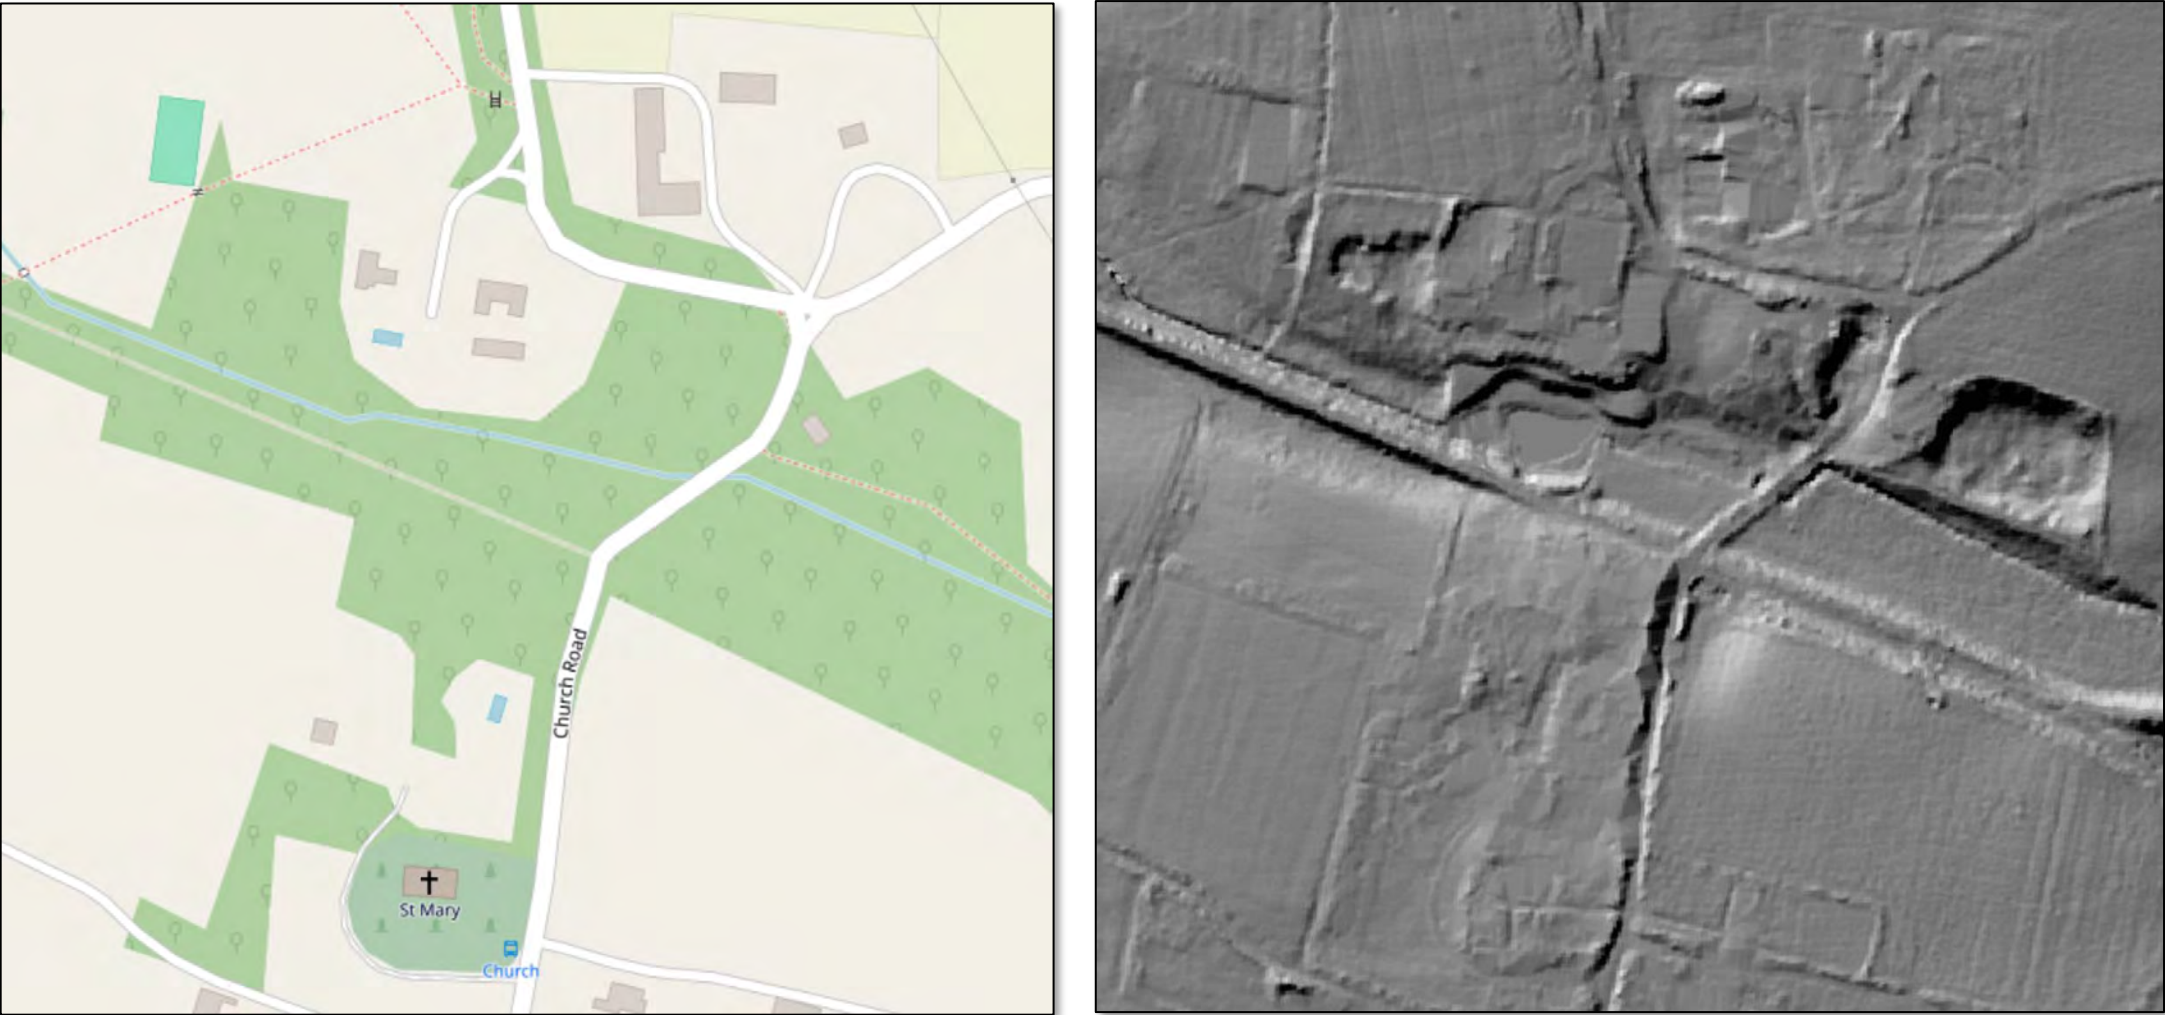
figure 169: **Zoomed in Map and comparative LIDAR image: Church and Bentley Hall area within the Bentley Conservation Area**
